ADDENDUM NO. 2

To all Bidders on the Project titled: CR_Project-0852: Demo OLD Library, Life Science and Physical Sciences Building implementation

CR_Project-0852: Demo OLD Library, Life Science and Physical Sciences Building implementation Utilities Demarcation

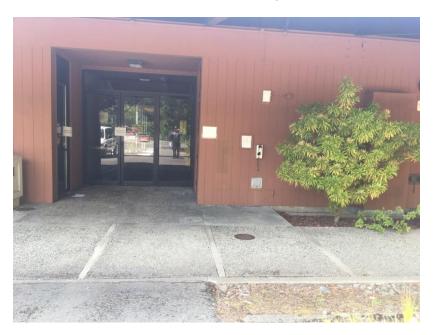
A. Picture number one is for Old Library water shut off

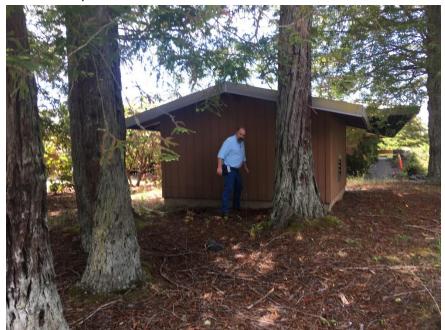
B. Picture number two is where both the sewer and the Storm drains are. They are both located in this approximate area. These will need to be sealed in concrete at both ends near the building and at the input to the main line

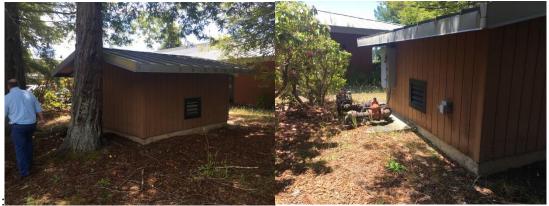
C. This Picture shows the transformer shed and water boost irrigation pump set up. The transformer shed and transformer go away as part of this demo. The booster irrigation pump will be pulled by the college prior to demolition start. There is a 12KV vault shown in photo

007 below. All 12KV infrastructure will either be abandoned in place or abated as much as practical. 3ph power into the Library will abated back to the transformer as much as practical.

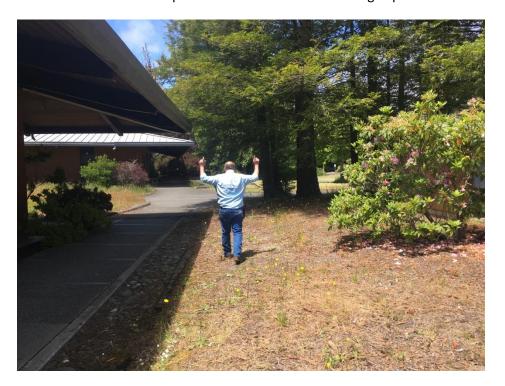
E. Picture number six is the hydronic lines tween the old Library and the Life Science building. Abate as much as practical. Abandon the remaining in place.

Note electrical room is somewhat in line with transfers. Pull wires from conduit and abandon. The college will be re-routing existing pathway lights that are currently powered at the library to other circuits prior to the demolition date.

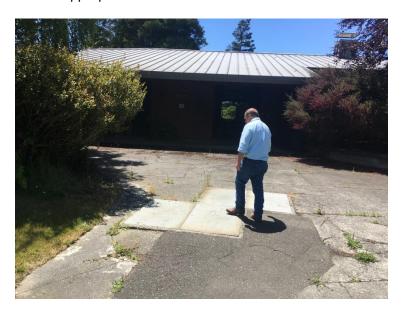
A. 12KV and other signals for Life Science would be abandoned back to these pull boxes as appropriate.

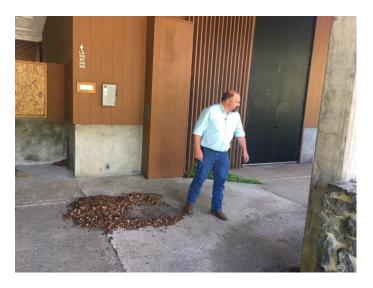
B. Picture number nine is likely a gas shut off valve for life science as well as sewer clean out. College will verify gas shut off from this valve

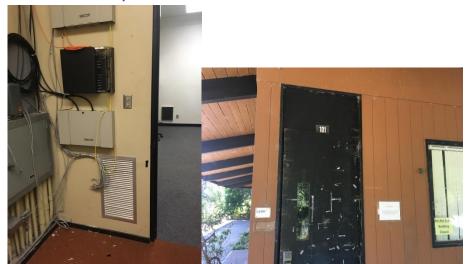
C. Pictures 10, 11 and 12 and 13 are in the life science building showing fiber. The college will have these inactive prior to the start of Demolition

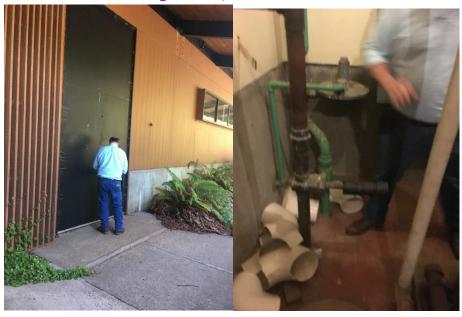
E. The pictures below show the boiler room. This shows the Water and gas line inside the building that should be isolated at the valves. **College will determine if there is a better external source of building isolation,**

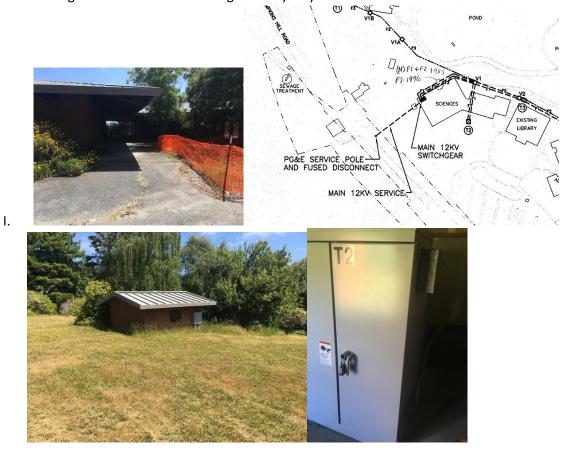
H. This picture shows the breezeway where 12KV runs from the trunk in front to the Transformer in the rear of the building. None of this 12KV nor the Transformer and shed to the rear of the building is to be demoed or damaged in any way.

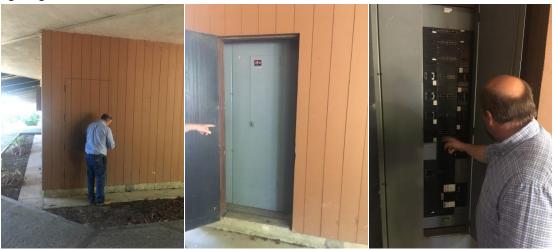
K. These photos shows where 208 3-Ph comes into Physical Science and then feeds over to Life Science. This power is to be disconnected at Transformer T2 and as much of the wire abated as practical. This conduit is to remain intact if at all possible. The college may re-use it for pathway lighting in the future.

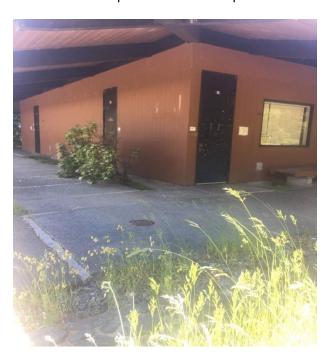
L. Picture 31 is back in front of LS101 showing a clean out for the rain water drain. These need to be left in place if the hardscape is not removed.

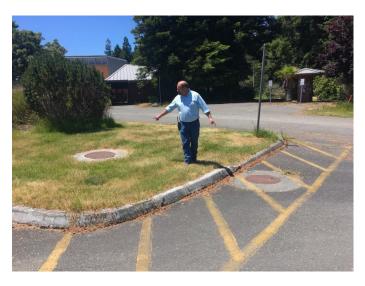
G. Picture number 17 shows the sanitary sewer and storm drain for physical science. Note it is some distance out from the building. The lines to both of these are to be sealed in concrete at both ends as part of the abatement and building demolition project.

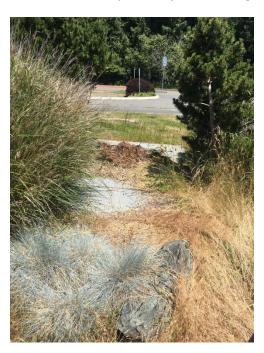
H. Picture number 18 shows the 12 KV lines heading over to the vault near the old library. Note that fire hydrant is just to the right hand side of this photo. Do not disturb Hydrant.

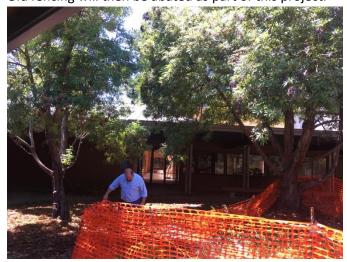
J. Picture number 20 shows an old break in the gas line that was repaired outside the Physical Science Building. These acacia trees should be removed and this area leveled with surplus soil. Old fencing will then be abated as part of this project.

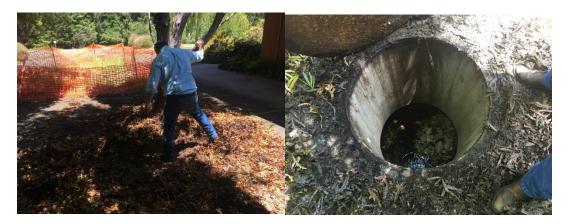
K. Picture 21 and 22 show the access to the neutralizer pit that contains oyster shell etc. This will be cleaned out by the college prior to Demolition and it is to be demolished and sealed so that the main sewer line remains intact.

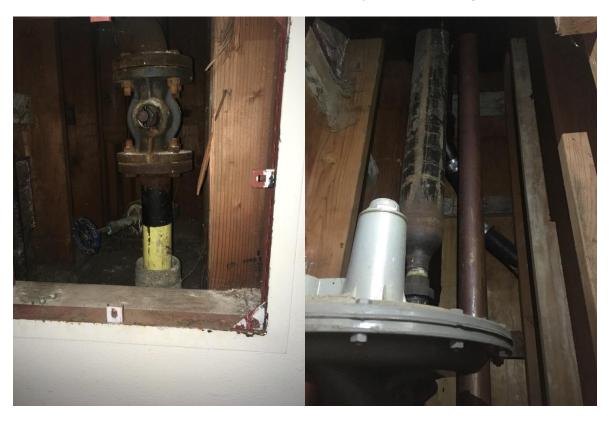
M. Picture 26 and 27 shows Water and Gas valve is located just on the other side of the wall inside the classroom PS 104. This may have to be the demarcation point for this gas. The college will later seal access to this valve from a location away from the building.

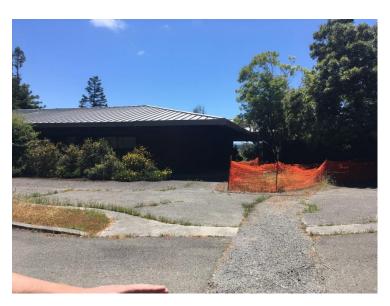
O. Picture 24 shows the hard scape outside the broken gas line most of this hard scape will go away back to the sidewalk.

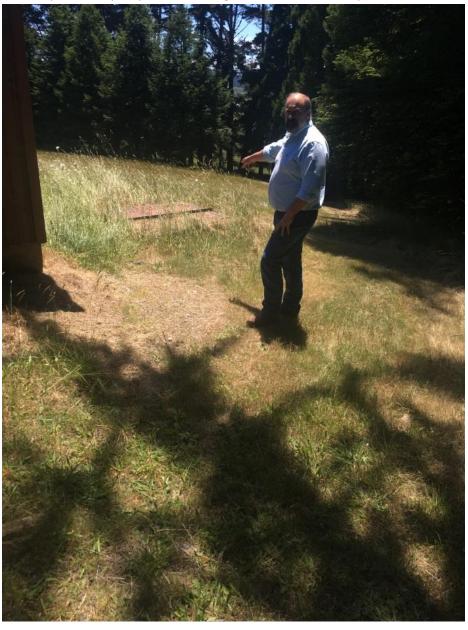
S. Picture 29 is the main 12 KV coming in to the campus behind Physical Science. This should not be disrupted in any way as it will bring down the entire campus.

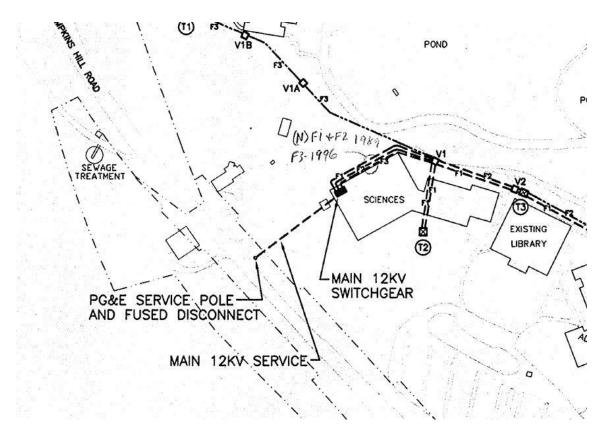
T. The Campus Main 12KV Switchgear is located in the North-West corner of the Physical Science Building. This Equipment will remain in operation throughout and beyond the building demolition. This portion of the building – less roof - is to remain intact as much as possible. The exterior of all remaining walls is to be abated of HAZMAT material as part of this demolition. Temporary cover is to be provided in the form of a supported Tarp or other method. The college will enclose this equipment at a later date.

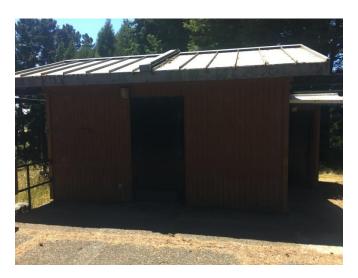
Picture 30 is the observatory. Abate with Caution as it sits on top of the MAIN campus 12KV feeder conduits.
